Coatings for Abrasive Service

The **Heart**
of Your
Process

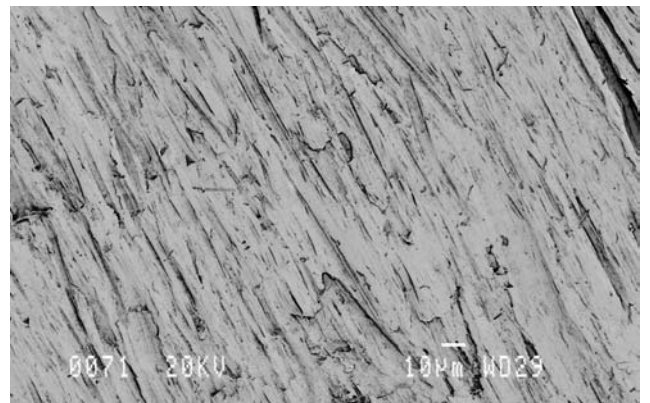
Metallurgical investigations can help to explain the type of wear mechanism that prevailed. The picture below depicts the scars in a balance drum caused by abrasive particles with a low impingement angle.

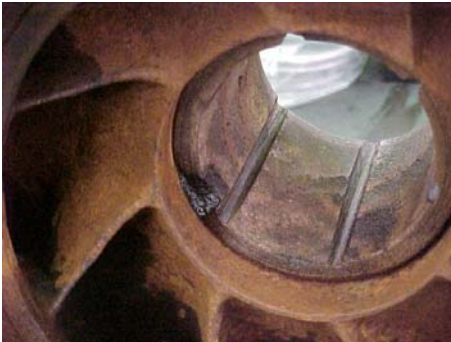
The pump was taken out of service due to high vibration. All bearings and impeller wear surfaces showed excessive wear. The pump was retrofitted with a fiber resin bearing, which did not last much

longer than the original carbon bearings. This prompted a thorough investigation including rotor dynamic analysis and a detailed investigation of the type of wear that was being experienced. It could be demonstrated that the sole cause of the damage could be attributed to the high content of quartz sand in the system.

The worn bearing bush (up to 6 times increase in bearing clearance) and the heavily scored bearing sleeve are shown in the photographs below. This bearing failure also caused the mechanical seal to fail due to the high vibration and to decrease the generated pump head and flow. The MTBF was 6 months, which was not acceptable to the user.

Worn resin bearing bush

The bearing bushings and the bearing sleeves were

then coated with the SUME[®]PUMP SH coating system. The parts could be replaced without changing the pump design. Now, the pumps have been in operation for 22 months without any increase in vibration or performance degradation.

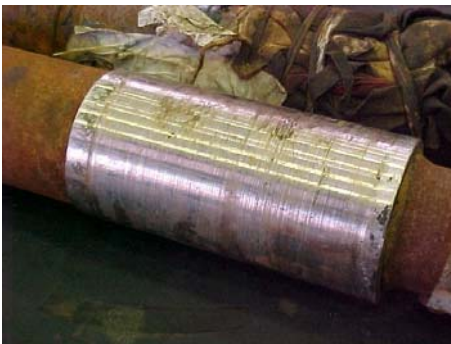
Worn bearing sleeve

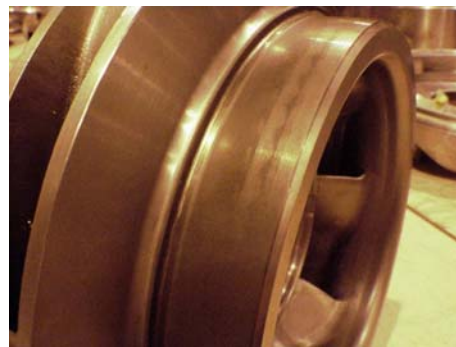
These upgraded pumps have now been in operation for 3 years with good success. The photos below show an impeller from the pump, that was taken out of service for inspection after 4800 running hours. The coated impeller eye wear surfaces showed hardly any wear and the coated impeller hub wear surfaces had a slightly increased running clearance and some score marks generated from 3-body abrasion.

Coated impeller eye ring

Based on the results of the coating development and the experience in pump design for abrasive applications, the SUME[®]PUMP SA coating system was selected for all the impeller wear parts and balancing device. In addition the expected part life for the given condition was estimated with the empirical method and was also used for the coating selection.

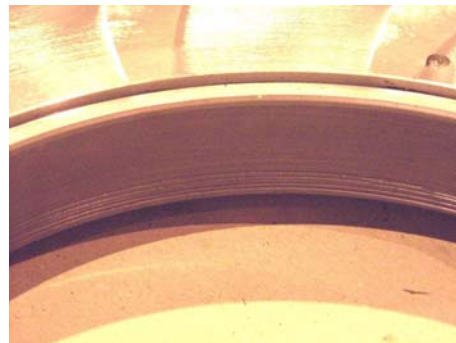
Coated impeller hub ring
